NOVEMBER 1955

# Approach

NAVAER 00-75-510

THE NAVAL AVIATION SAFETY REVIEW

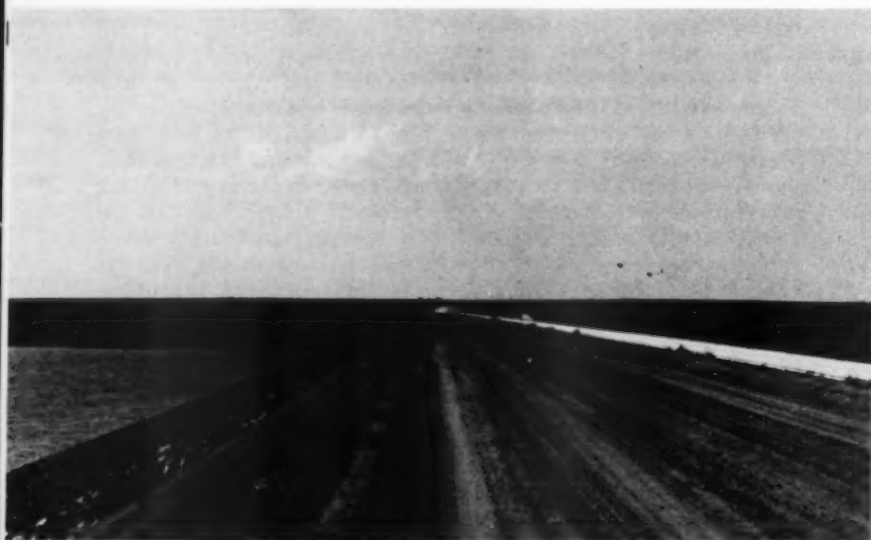
"Number 4 man elected to attempt a landing on this dam."

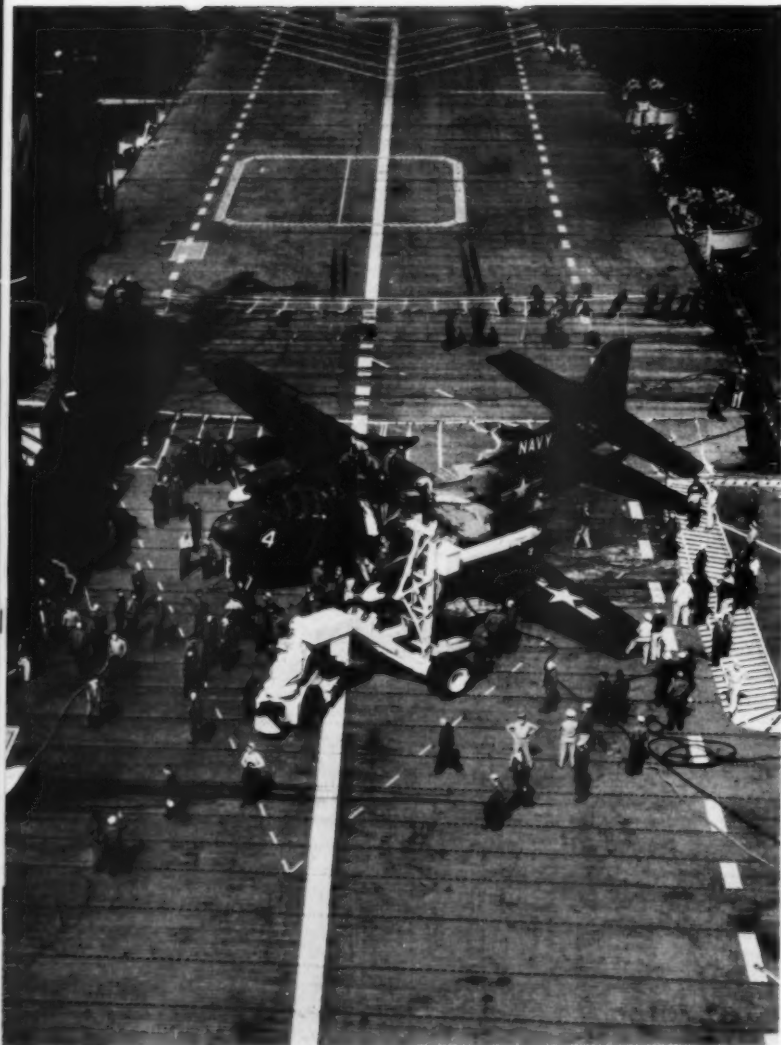
The AJ's barrier engagement was successful, but that's all she wrote!

The aircraft skidded into the barriers engaging numbers 3 and 5 with the main gear. There were no personnel injuries but the aircraft sustained strike damage.

The accident board concluded that the primary cause of the accident was the combination of a low approach from the 45-degree position and the pilot's error in dropping the nose in the groove. Major contributing factors were the failure of the LSO to correct the low position.

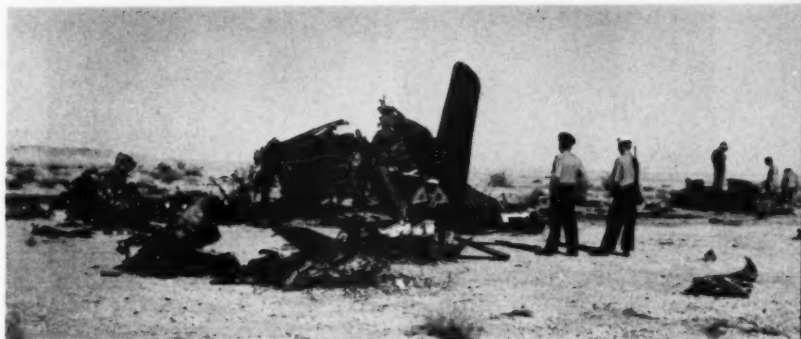
Unfortunately, this account does not end here. Another member of the bombing flight, observing the crash, descended immediately and, with gear down began circling the scene. After changing from a right-hand orbit to a left turn, the plane's altitude became so low as to cause the crash vehicle to fire a warning flare. Apparently intent upon his task of directing the crash crew, the pilot ignored the warning. Shortly thereafter he was seen to retract his gear, whereupon the airplane commenced a roll to the left and crashed, killing the pilot.

1. Pilot error . . . flying dangerously low and slow in steep turns.
2. . . stall/spin from which no recovery was possible due to excessively low altitude.
3. . . pilot remained at the scene longer than was necessary.
4. . . pilots review frequently the stall warnings and

While observing a crash scene, the pilot neglected speed and altitude.

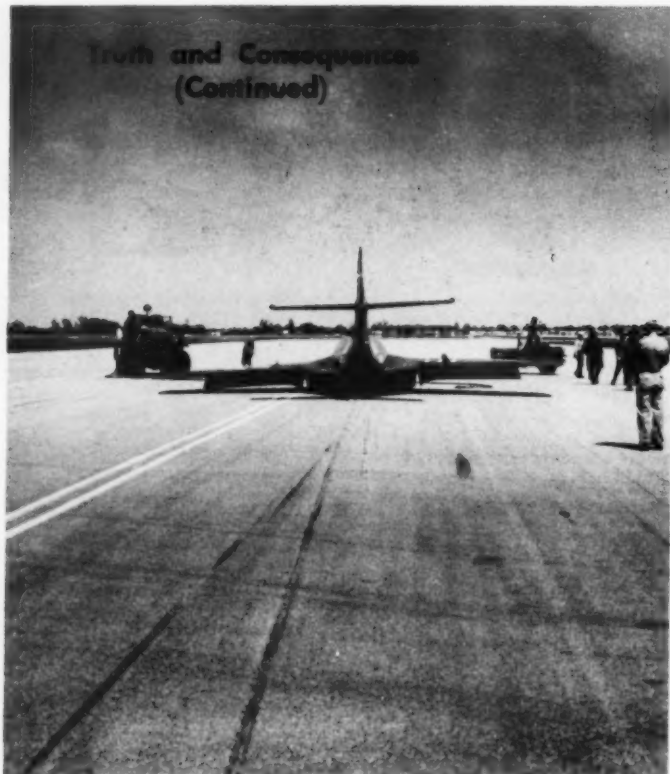
The runway signalman waved and waved but nobody was at home.

*During his approach the pilot reported gear down for touch-and-go. The aircraft was over the approach end of the runway before the tower observed the no-wheels condition and a warning to wave-off was given too late to be effective.*

The accident board recommended that the runway signalman fire a Very's pistol signal immediately upon discovering an aircraft in the landing approach with wheels up. This procedure was felt appropriate in respect to jet aircraft due to the greatly increased closing speed and slow rate of acceleration.

It was recommended that if tower operators are unable to observe the landing gear by the use of binoculars, they should be instructed to observe the runway signalman if possible. This is to ascertain whether a wave-off signal is given, in which case the tower should warn the pilot by radio.

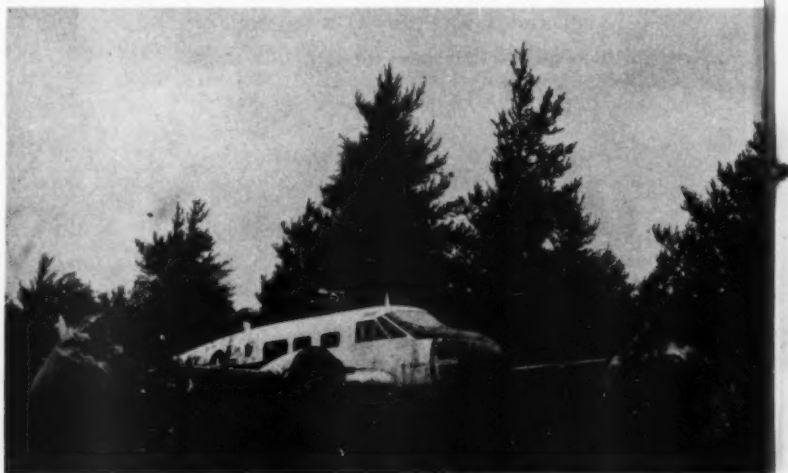
Suddenly finding himself with no fans at all, the pilot headed for a clearing.

right main and the right auxiliary tank; as the latter tank was exhausted, air was drawn into the fuel lines, (b) fuel selector being on right auxiliary tank, a dry tank, (c) failure to complete the check-off list by leaving the mixture control in the lean position.

It was recommended that all pilots review their own fuel management habits, the objective being a fresh approach to make sure that their routine has not become a mechanical, automatic process.

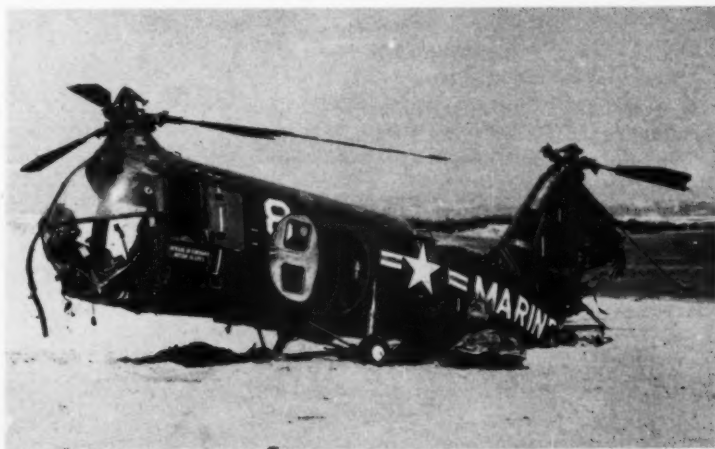
As evidenced by the accompanying photograph, the aircraft sustained strike damage. The pilot received fatal injuries and the passenger was seriously injured.

In its analysis of the crash the accident board was of the opinion that the pilot did not check the wind prior to entering the maneuver and was unaware of the windshift. The board's recommendations included the practice of providing a windsock at any site used for practice autorotations and excluding passengers from flights where such maneuvers are to be practiced. ●

The surface wind shift was un-noticed.

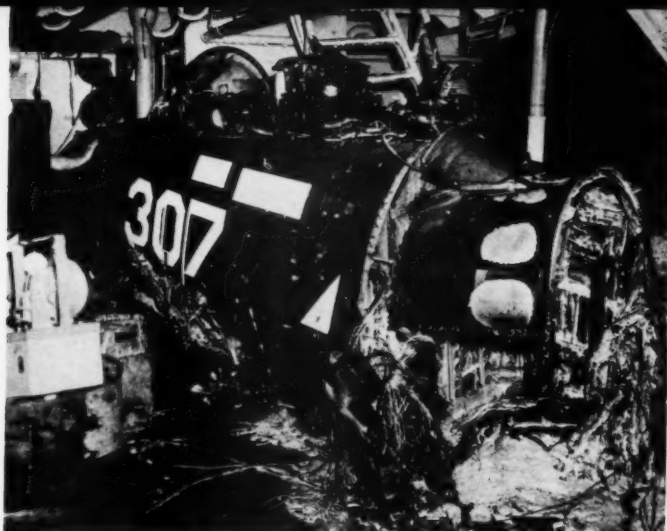
... And the F2H pilot actually walked away!

The pilot was able to scramble, unassisted, from the cockpit section which was wedged in the fantail. He sustained no serious injuries. The effective use of shoulder harness, safety belt, protective helmet and oxygen mask undoubtedly enabled the pilot to survive this most unusual accident.

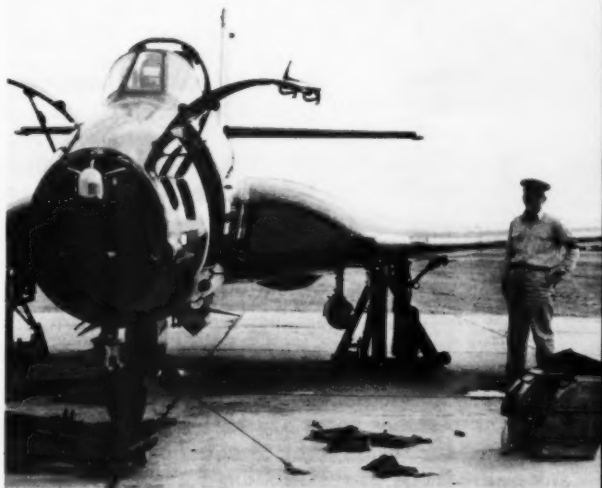
Firing with boresight tube installed was fatal to an AO.

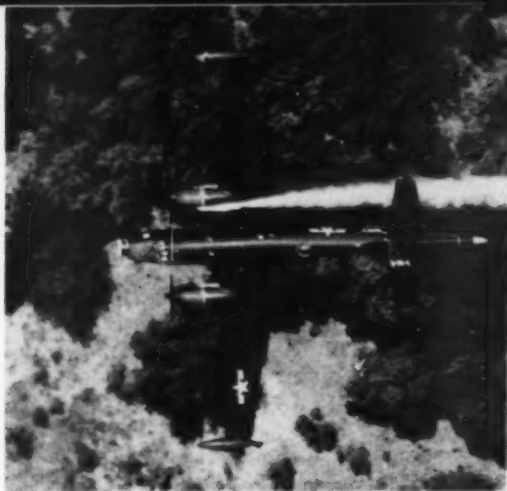
This P2V in-flight fire occurred when the starboard engine failed internally. After a successful forced landing, bearing material found in engine sumps indicated possibilities of oil starvation. Too late to save this engine but it's not too late to save others from this malady.
